# **Fukushima Nuclear Accident and Roadmap for Decommissioning**

*~A TEPCO Nuclear Engineer's Perspective~*

*Presentation for Program on U.S.-Japan Relations  
Harvard University*

*Cambridge, Massachusetts  
December 3<sup>th</sup>, 2013*

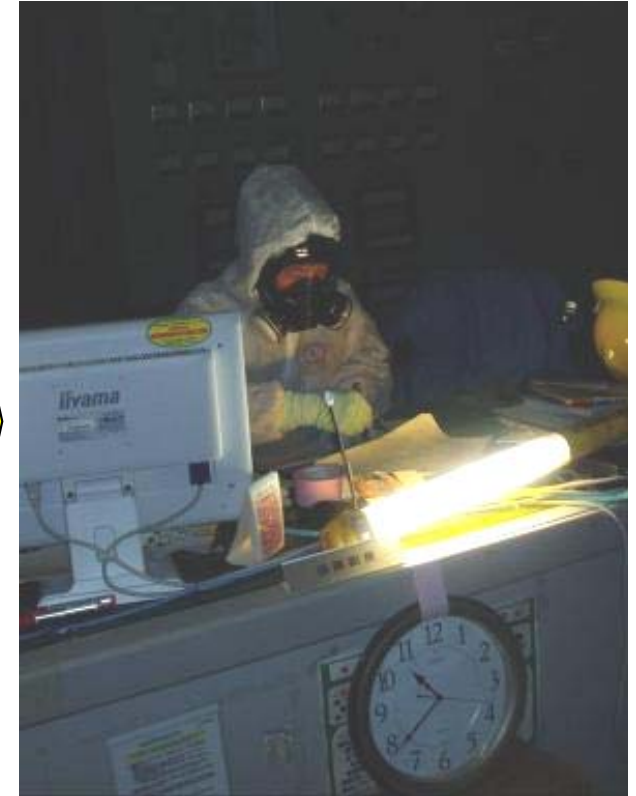
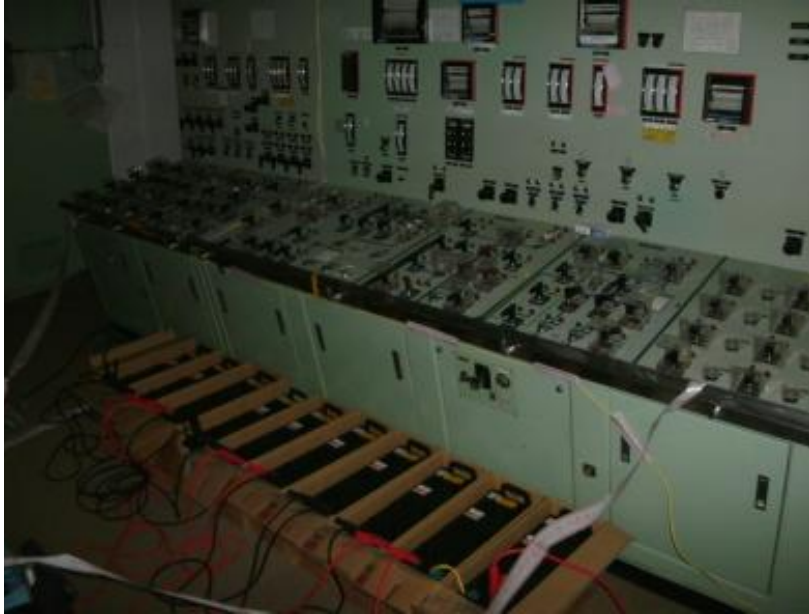
Brought in heavy batteries to restore instrumentations

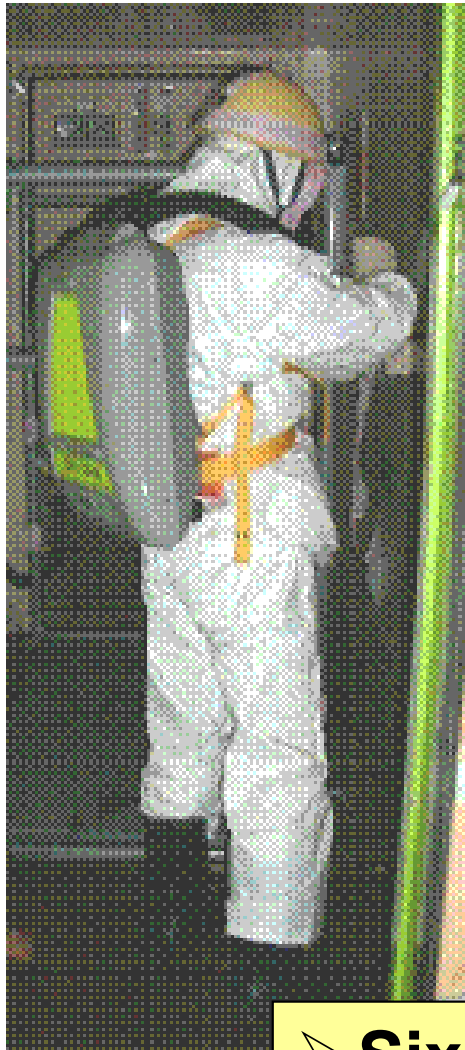
# Accident Response at 1F: Unit 1 Containment Venting

- Six men formed 3 “**last-resort teams**” to manually open 2 valves in **highly-radioactive area**
- Core damage already progressing by this time (3/12 9:04-9:30)

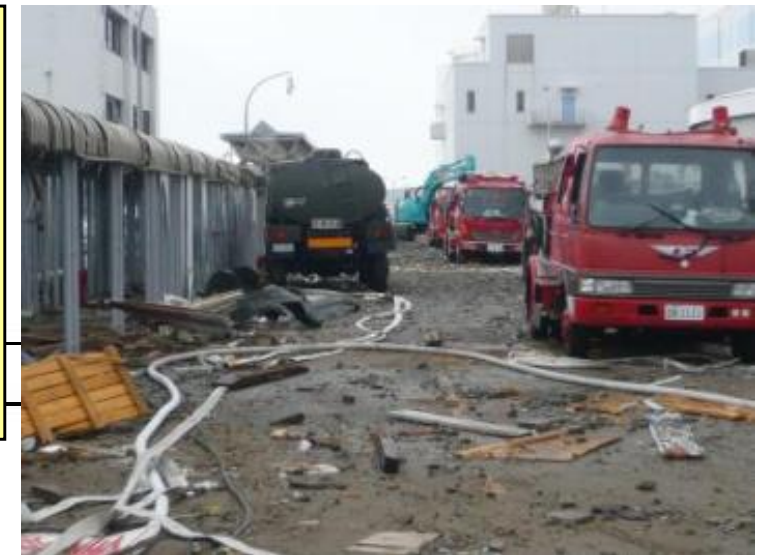
# Accident Response at 1F: Water Injection by Fire Trucks

- Fire trucks played critical role in injecting water into reactors
- Fire brigade operated fire trucks amidst high radiation/successive explosions

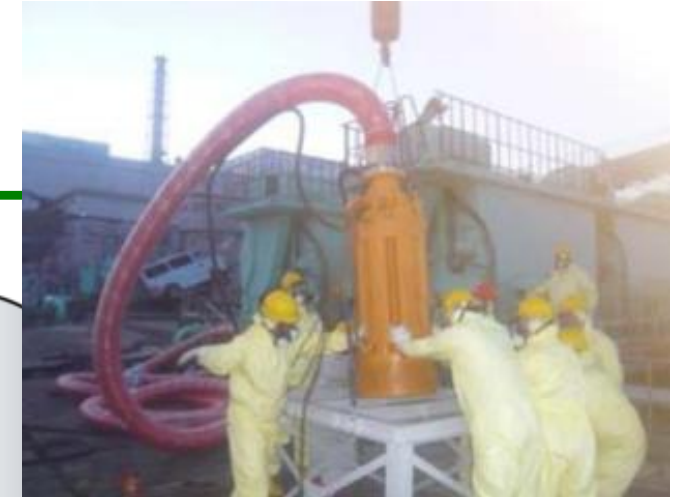
# Accident Response at 1F: Protecting Units 5&6

- Ultimate heat sink restored: 3/19
- Cold shutdown achieved: 3/20
- ➔ **Determination to save Units-5/6**

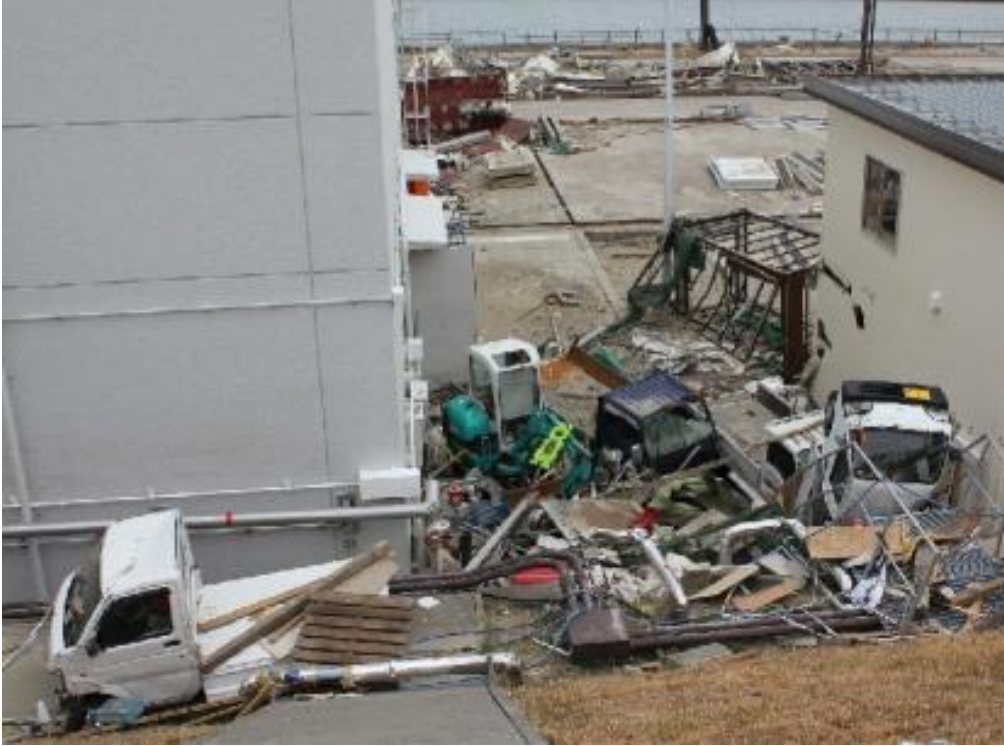
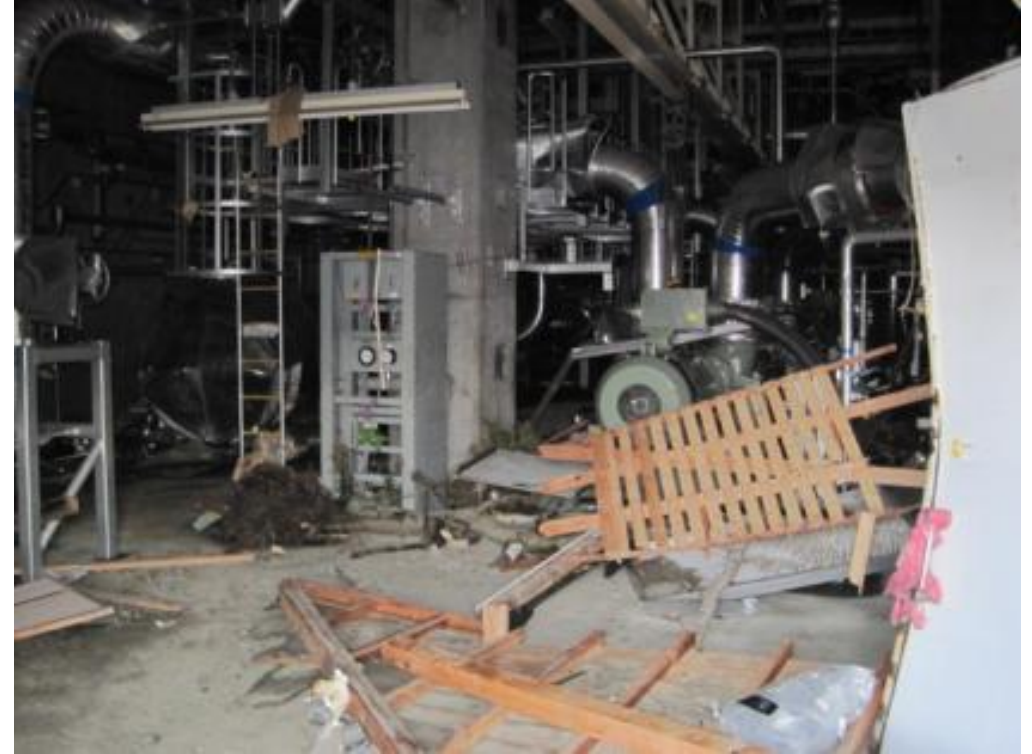
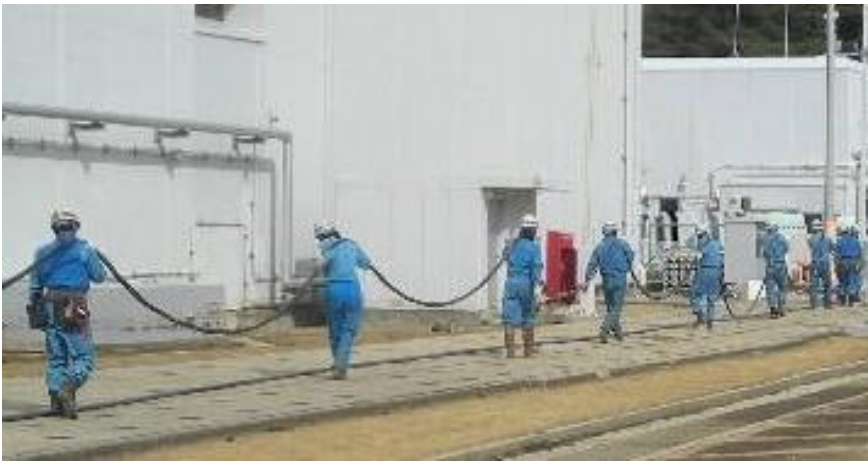
# Accident Response at 2F: Recovery from Tsunami

- Restored ultimate heat sink by:
  - ✓ Laying 9 km of heavy power cables by hand
  - ✓ Rapidly procuring and replacing motors
- Executed “**FLEX On-The-Fly**”

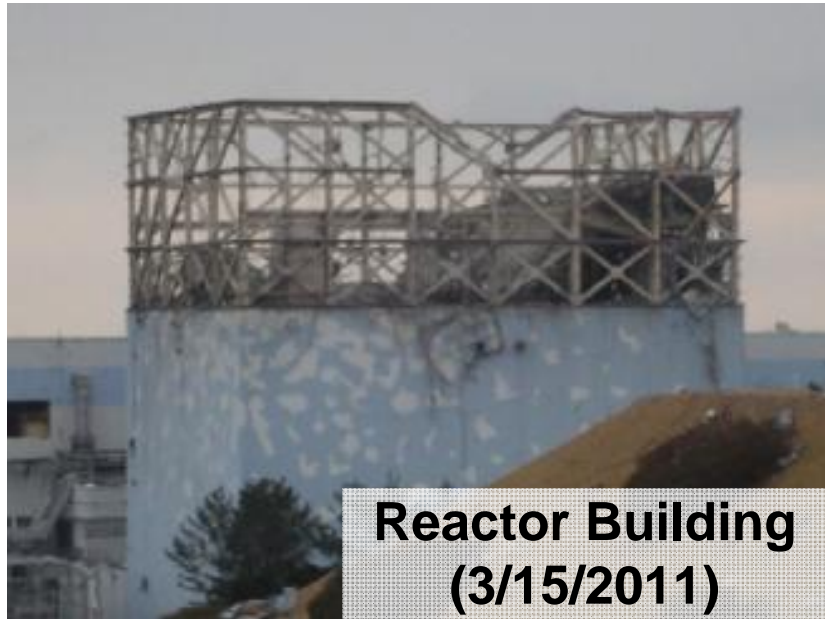
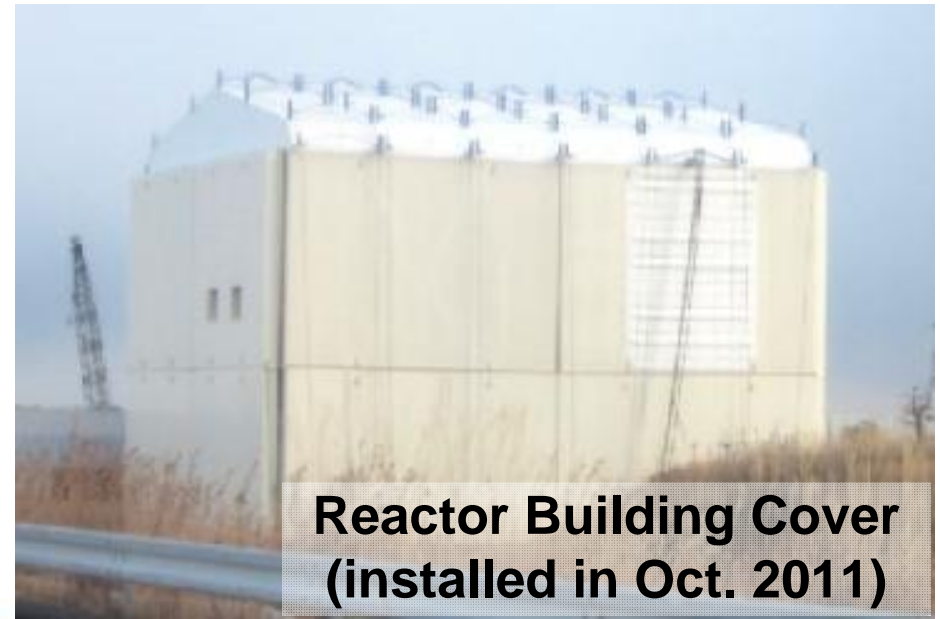
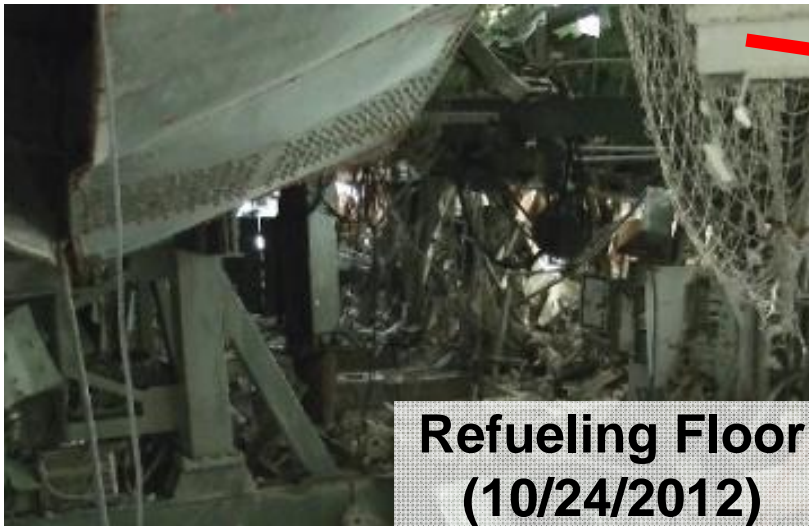
# Progress Made at 1F Unit 1

**Reactor building cover to be dismantled to enable rubble removal work to be conducted on refueling floor**

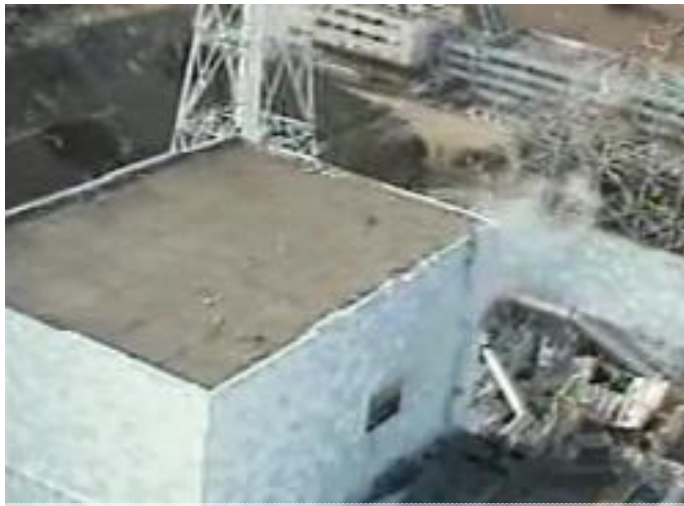
Steam Coming Out From Blow-out Panel (4/10/2011)

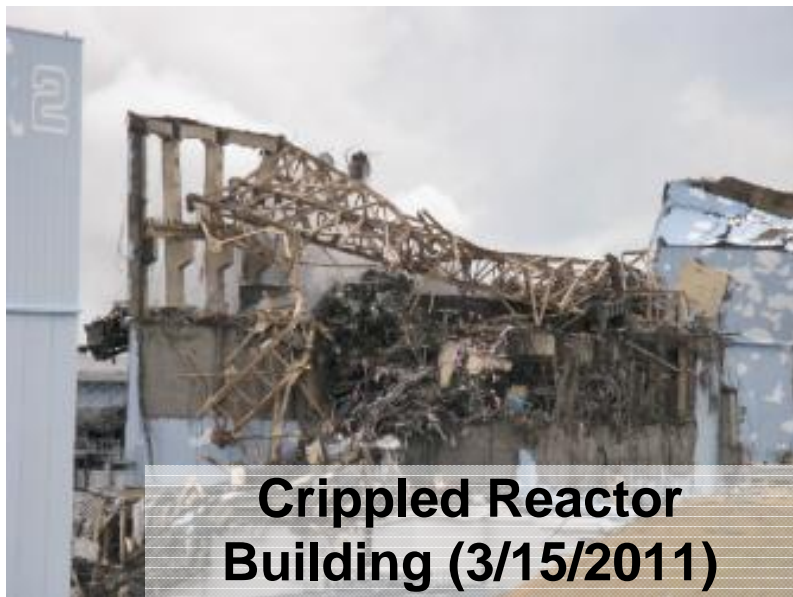
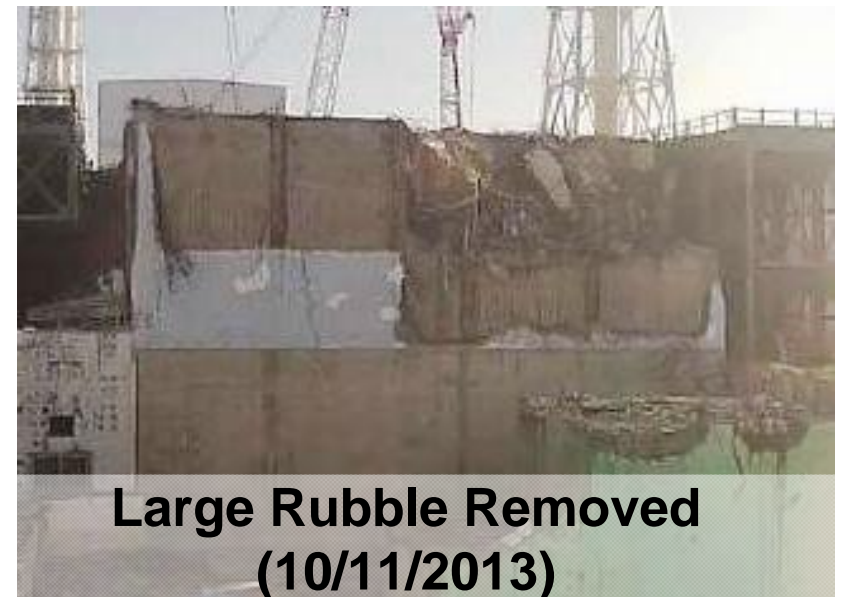
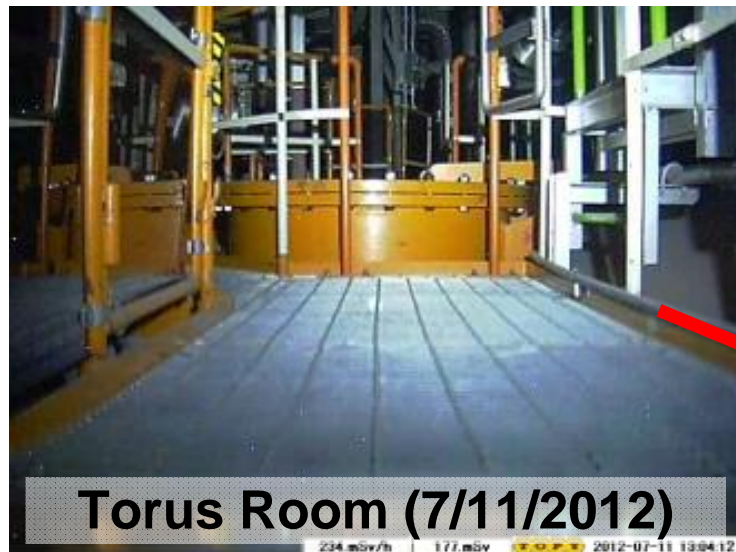
# Progress Made at 1F Unit 3

**Preparation work underway to install fuel removal structure**

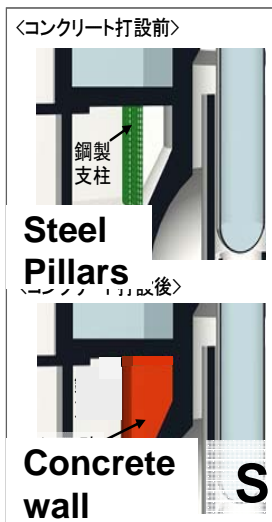
SFP Structure Reinforced  
(7/30/2011)

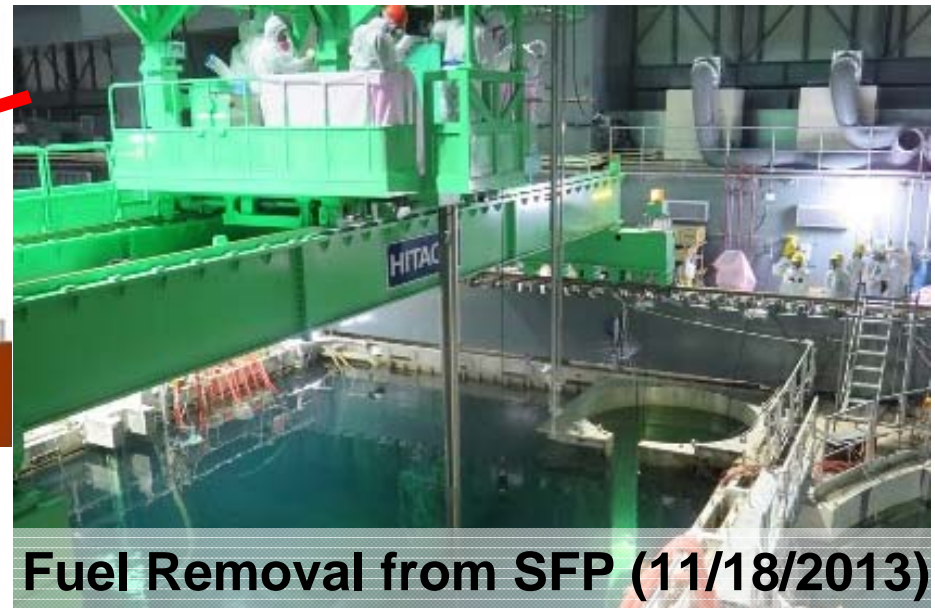
**1,533 fuel bundles being transferred to common pool**

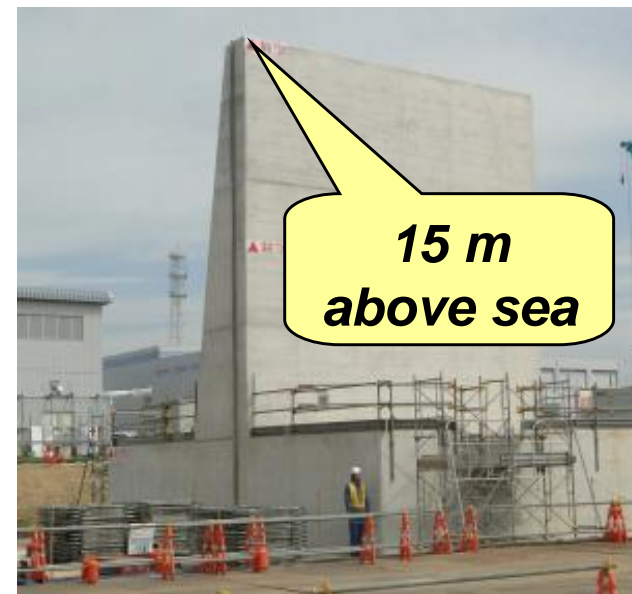
Sea wall (1.5 km long)

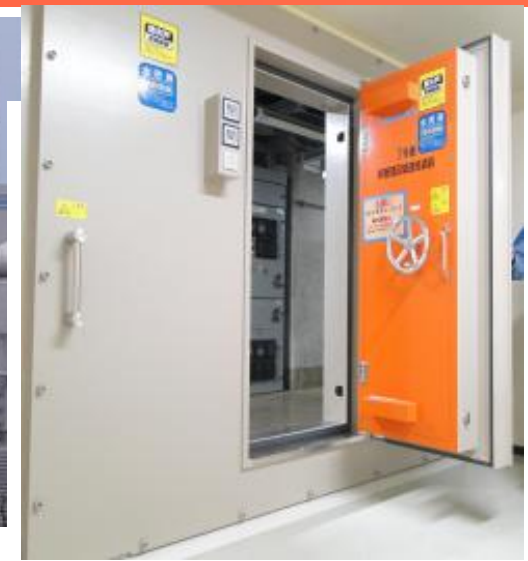
Water-tight doors (~60 places)

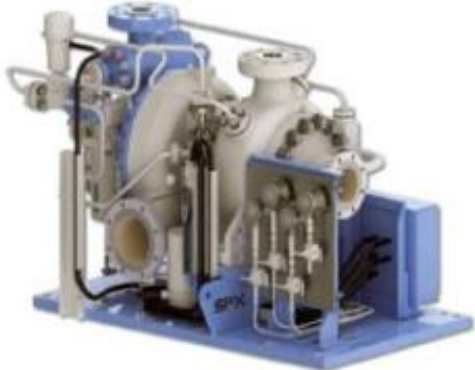
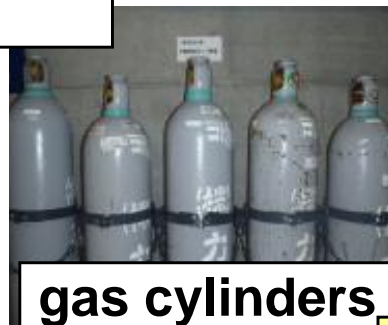
## High Pressure Alternate Cooling System

gas cylinders

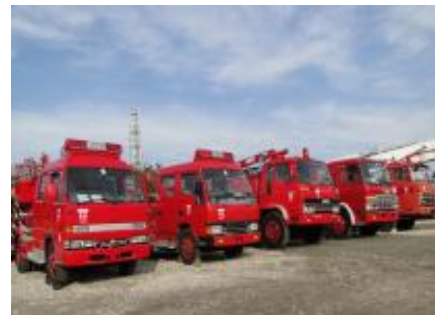
Fire engines: 8

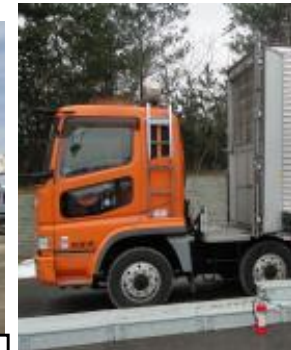
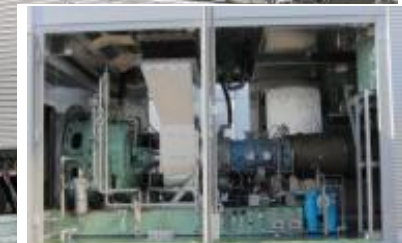
Gas Turbine Generators: 2

D/G trucks: 23

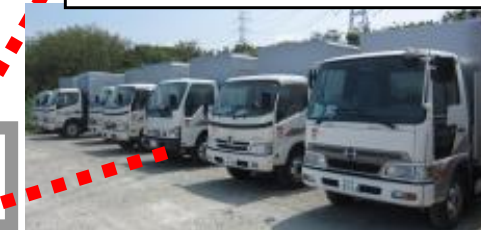
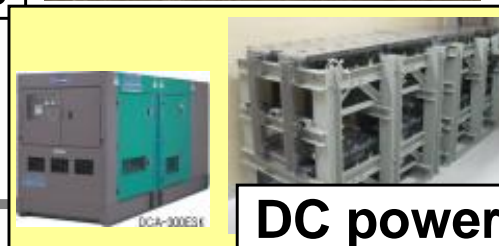
DC power

Emergency power supply

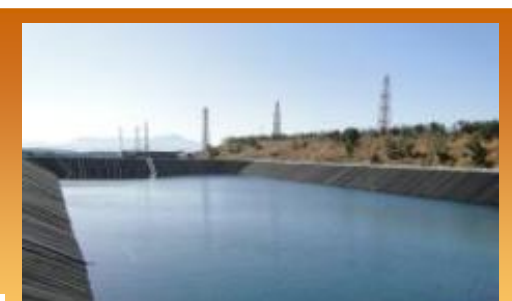
Fresh Water Reservoir: 20k ton

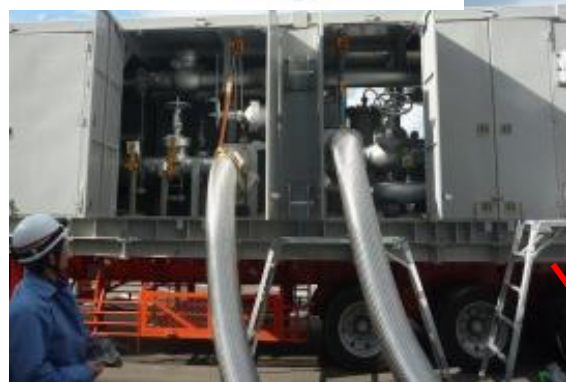
Alternative heat exchangers: 7
